# Genesis Models ED1 & ED2

## CASE STUDY

### MODEL ED1 INSTALLED ON DESALTER AT REFINERY

**Model ED1-210B-310 Multiphase Detector with  
PEF-5400-A00-01-106 Pentarod probe**

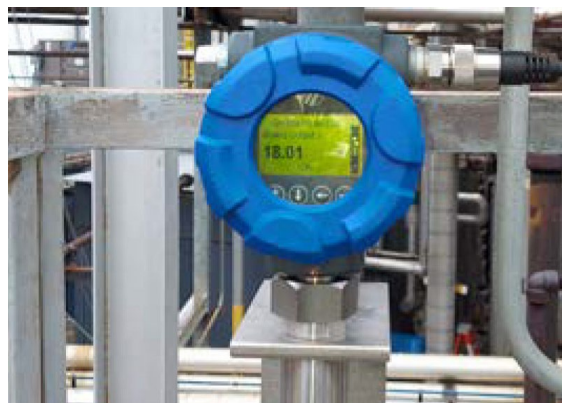
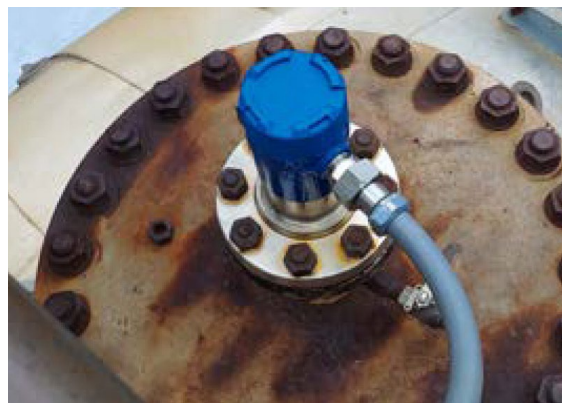
This study presents the immediate results, but over time, an even greater return may be seen in terms of reduced corrosion and fouling in downstream piping/equipment due to tighter control of the emulsion. In addition, level control accuracy was improved from  $\pm 15\text{--}20\%$  around the setpoint with the displacer down to  $\pm 1\text{--}2\%$  with Genesis. The operator has benefited by this improved control in both time (with respect to maintenance) and money savings (with respect to chemical additives). The next step is to install a longer probe in place of the torque tube. A longer probe resting closer to the bottom of the vessel will allow earlier sand detection. Knowing the level of the sand will allow the operator to properly plan shutdowns, instead of routinely shutting down the vessel every six months for cleaning. It must be noted that not all desalters will have sand accumulation; however, many separators will indeed have sediment/sand and this device will provide enhanced visibility to all levels. The goal from the onset was to have Genesis control the levels in the vessel; however, it happened a little quicker than expected. A true success story with this new and exciting product!

Commissioning test results were verified by comparison to visual samples taken from side taps, with initial indications showing a torque tube error of up to 20%. Three weeks later, an upset within the vessel was significant enough to disable the torque transmitter to the point where it would no longer read below 70% level. At one stage during the displacer malfunction, it was proven (by customer via side taps, and later by viewing the %Water Graph on the Model ED1 DTM) that there was actually water ABOVE the oil in the vessel, as described by the customer:
